TITLE: Avalon Command Surface Software Update

Avalon Viper II System Troubleshooting Guide

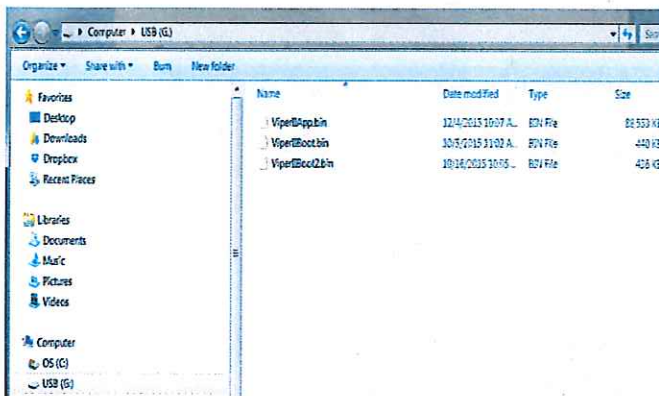
1. Before initiating software update ensure robust battery supply is connected to system with sufficient charge to keep system energized during 3-5 minute update process.
2. Place update files onto blank USB stick at the route directory. Do not rename the files or place them inside a folder. Updating the Avalon Application software requires three files. Updating the Copro software requires a single file.

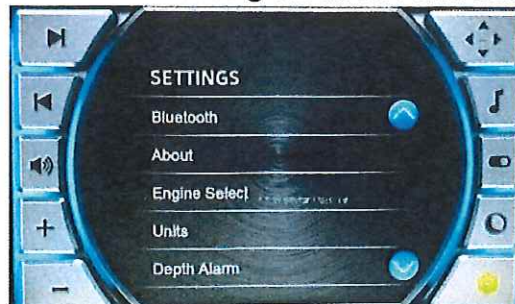
3. Insert USB stick with software update files into either of the Medallion Viper II module's USB ports.
4. Navigate the user interface to the Settings by pressing the Settings tab
5. Scroll to the "About" screen using the arrows and select by pressing "About".

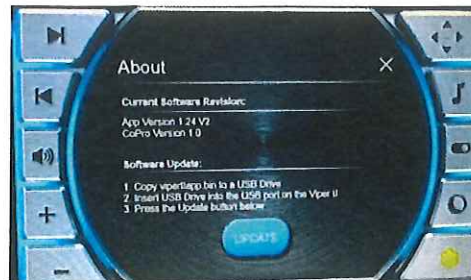
6. Review and document the existing software revisions before Updating.

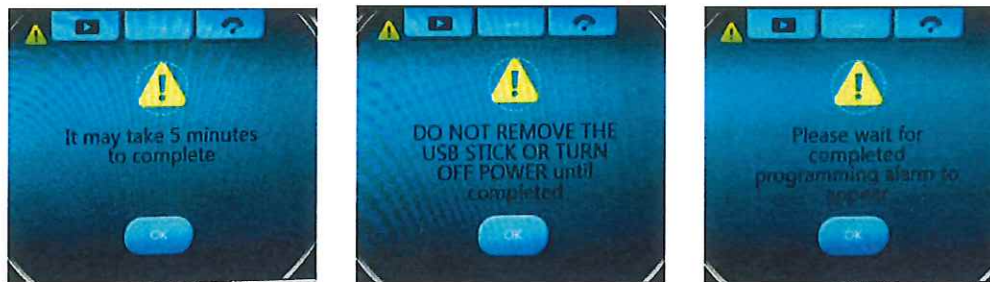
7. Press "Update". This will initiate update process and a screen prompt will present in the center of the 12" display. The screen prompt will provide the user update status. "Do not power off the unit or remove the USB stick during the update process"

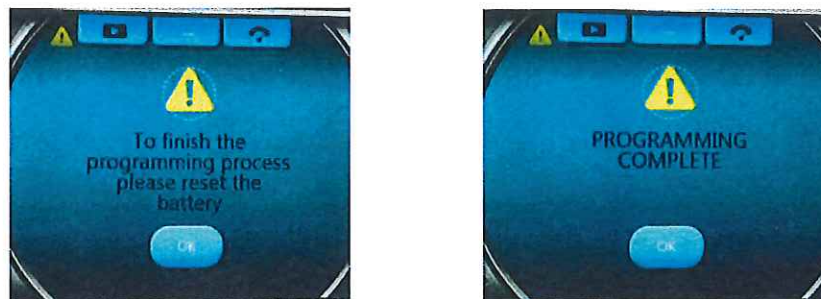
9. Once the update process has complete the screen will provide information to the user depicting so. It is then safe to turn the boat's battery switch off and then back on to reboot the Medallion Viper II module.
